# CORE DIFFERENTIAL IDENTIFICATION

TABLEAU D'IDENTIFICATION DE DIFFÉRENTIEL - IDENTIFIZIERUNG VON DIFFERENZIALE - IDENTIFICAZIONE CARCASSE DIFFERENZIALI - DIFFERENTIELEN STATIEGELD IDENTIFICATIE - DETALLES DE IDENTIFICACIÓN DE LOS DIFERENCIALES - SZCZEGÓŁY IDENTYFIKACJI TYPU DYFERENCJAŁY - ИДЕНТИФИКАЦИЯ ДИФФЕРЕНЦИАЛЫ

## CORE INSPECTION PROCESS

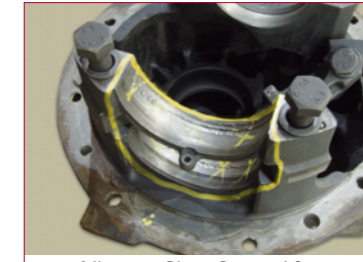
Adjustment Ring – Damaged Cups

Description	Percentage Deduction of Full Core Value
Product not in an active core group within the Meritor CVA core series	100%
Cracked, Bulging, Broken Carrier	50%
Damaged Spigot Bore Area	50%
Missing Parts due to physical removal	50%
Burned Up Core	50%
Excessive Weld	50%
Disassembled Core - complete	100%
Core Not Drained of Oil	€100 Deduction
Excessive corrosion	50%

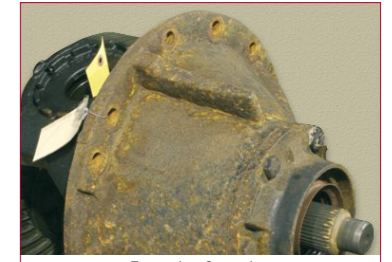
Excessive Corrosion

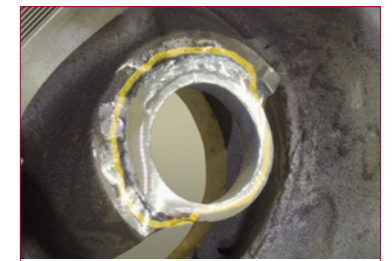
Welded Spigot Bore
